Memorandum

Date: *August 15, 2014*

Subject: *Oversight Summary Report
CPG Oversight of RM 10.9 Removal Action
Lower Passaic River Restoration Project*

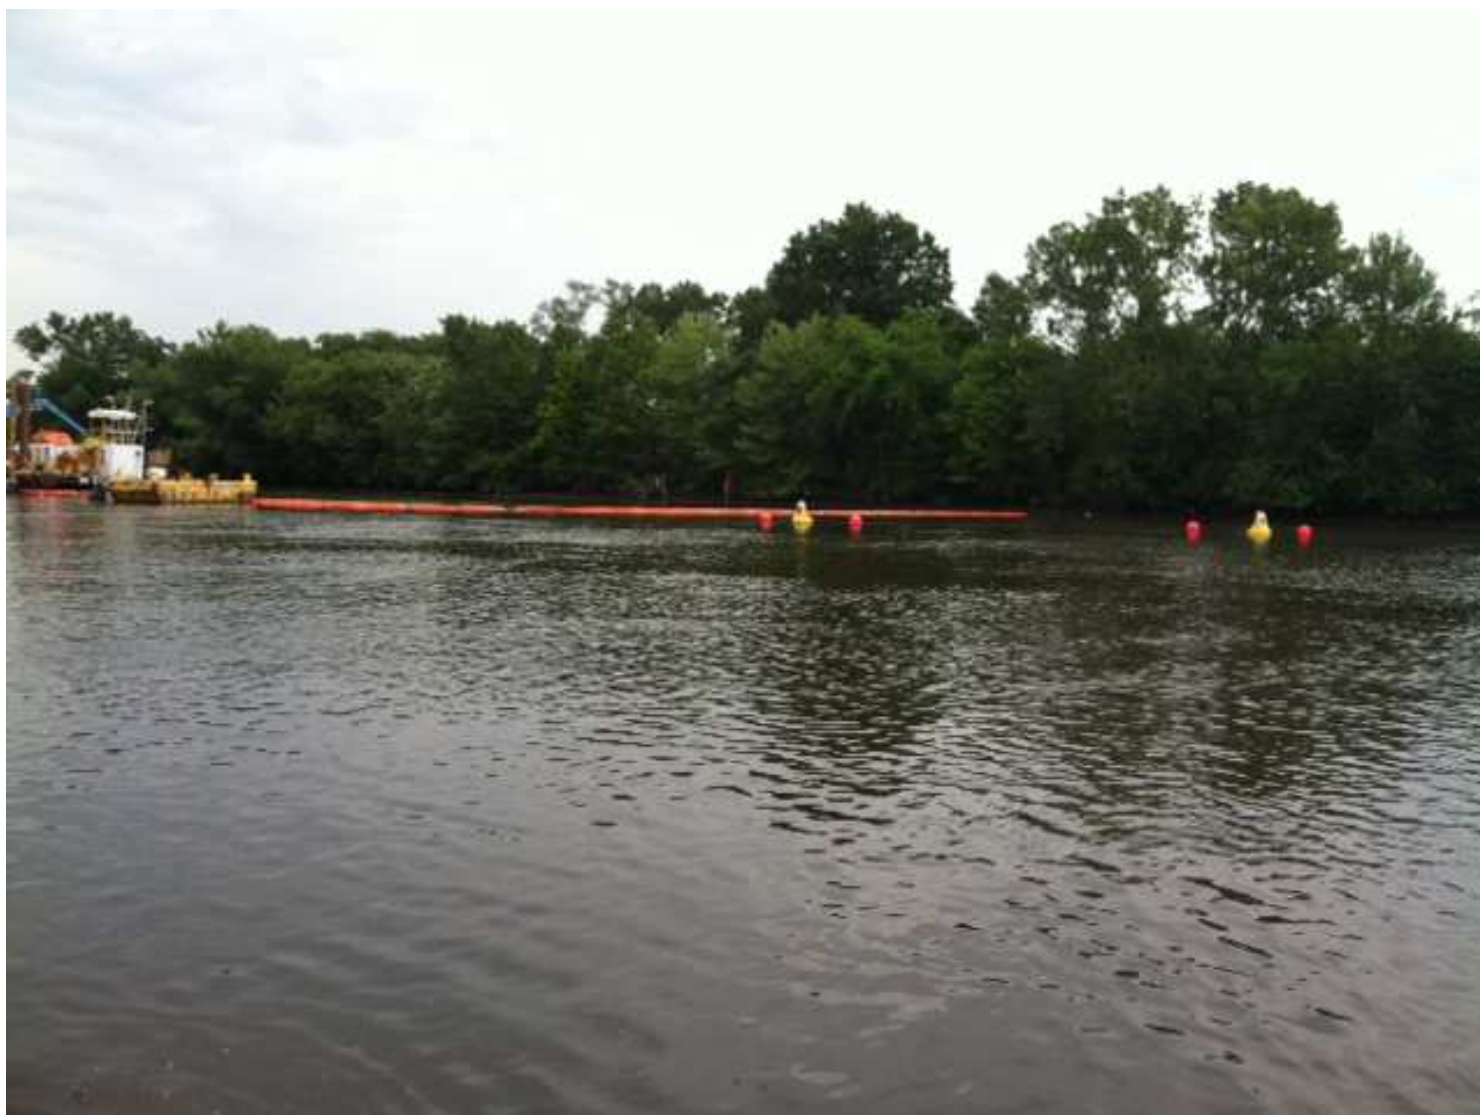
August 3 2013: Buoys 2 and 5 downstream of dredging

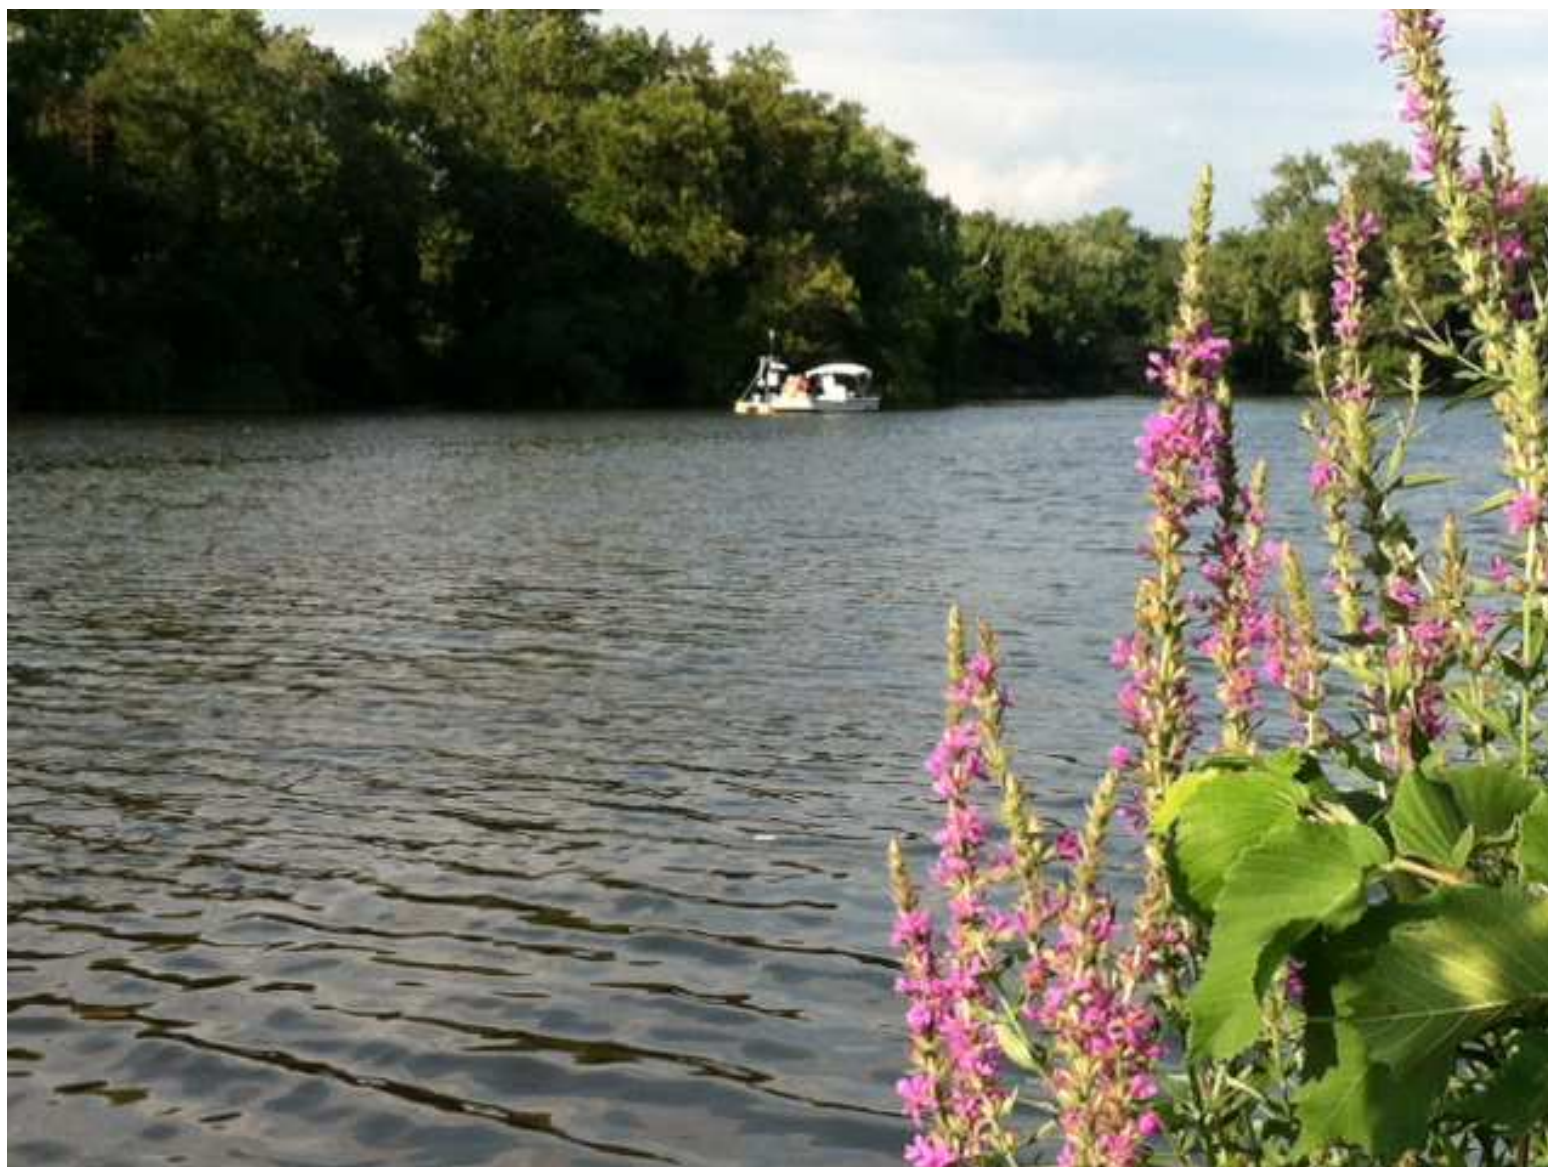
August 3 2013: CH2M Hill moving in-river air monitor to be downwind of dump scow (moved later)

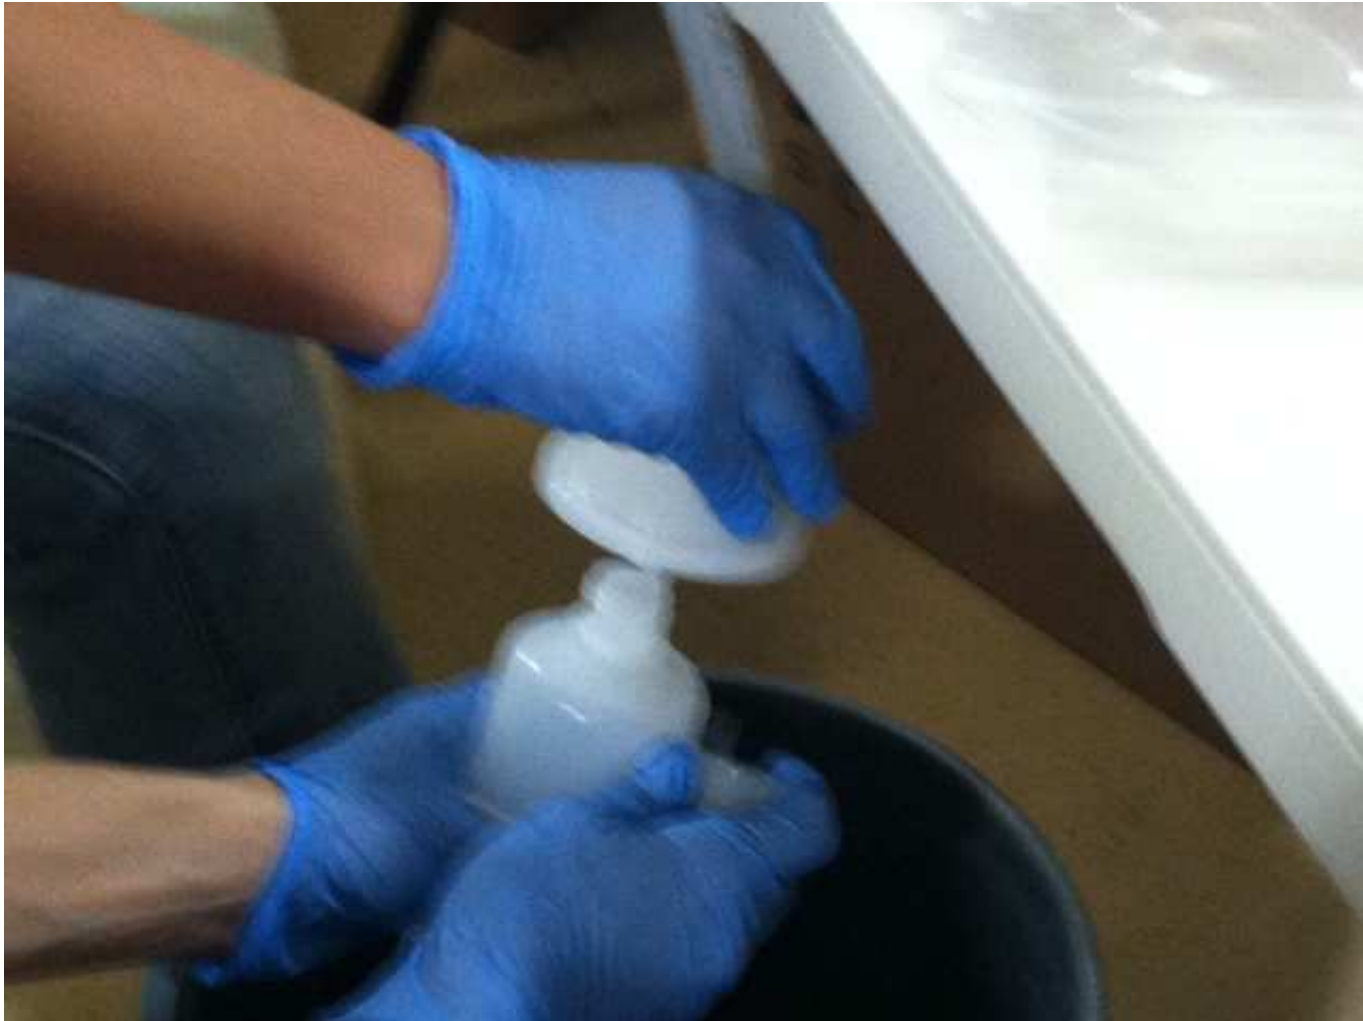
August 5 2013: CH2M Hill filling dissolved mercury bottle through 0.4 micron filter

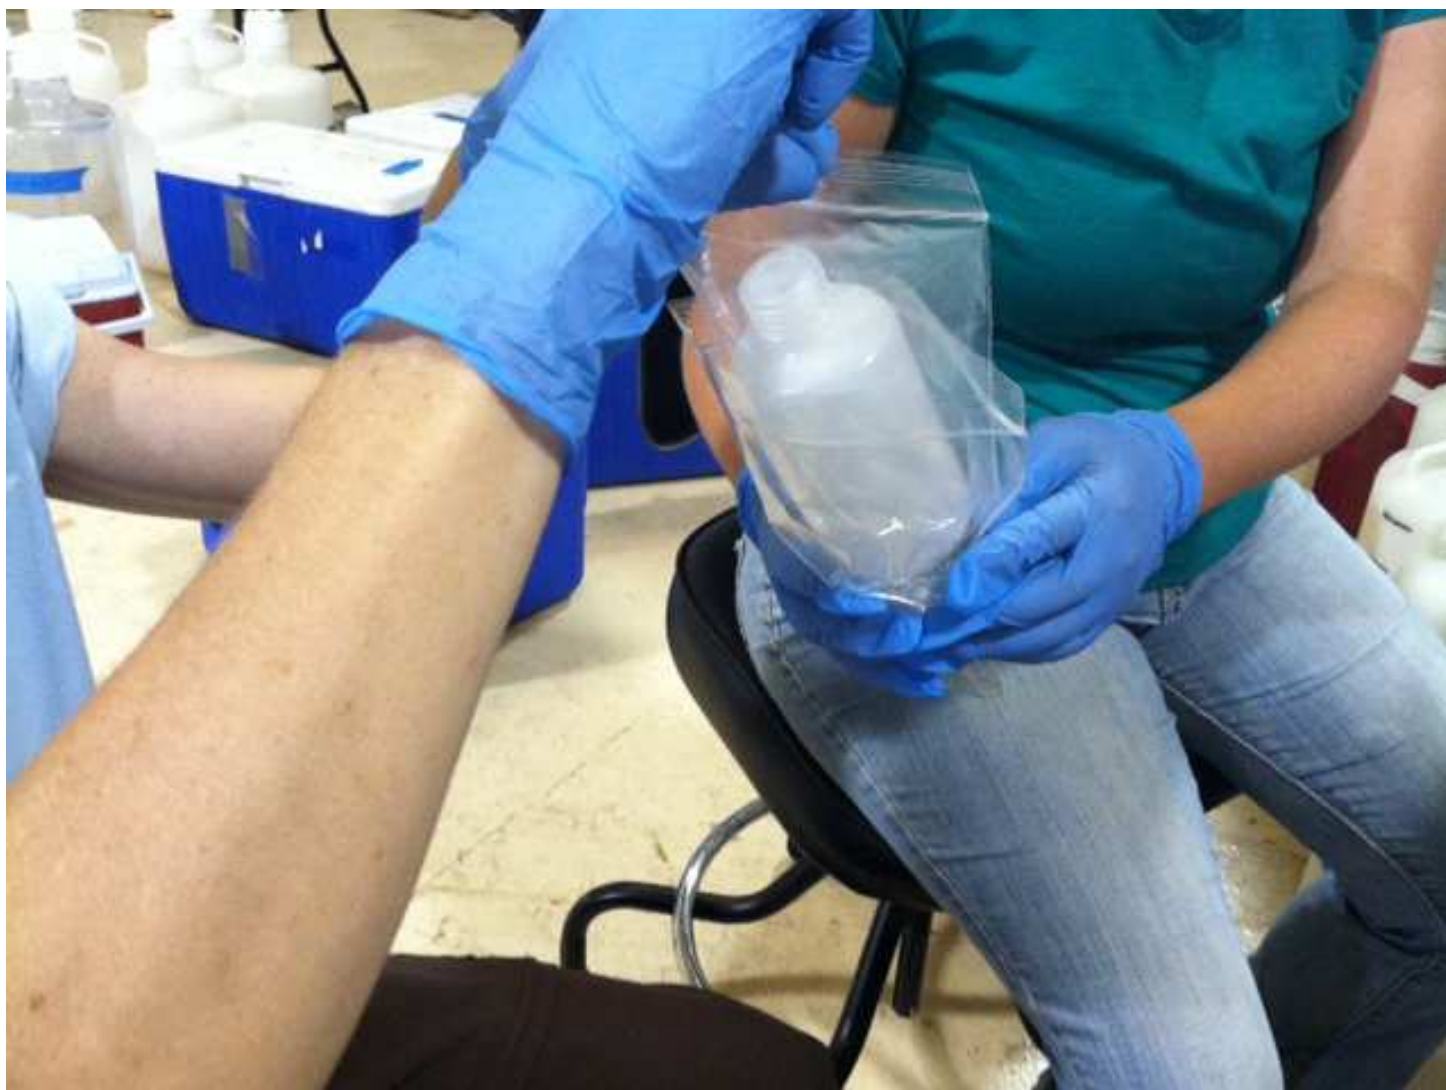
August 5 2013: CH2M Hill filling total mercury bottle using Clean Hand technique

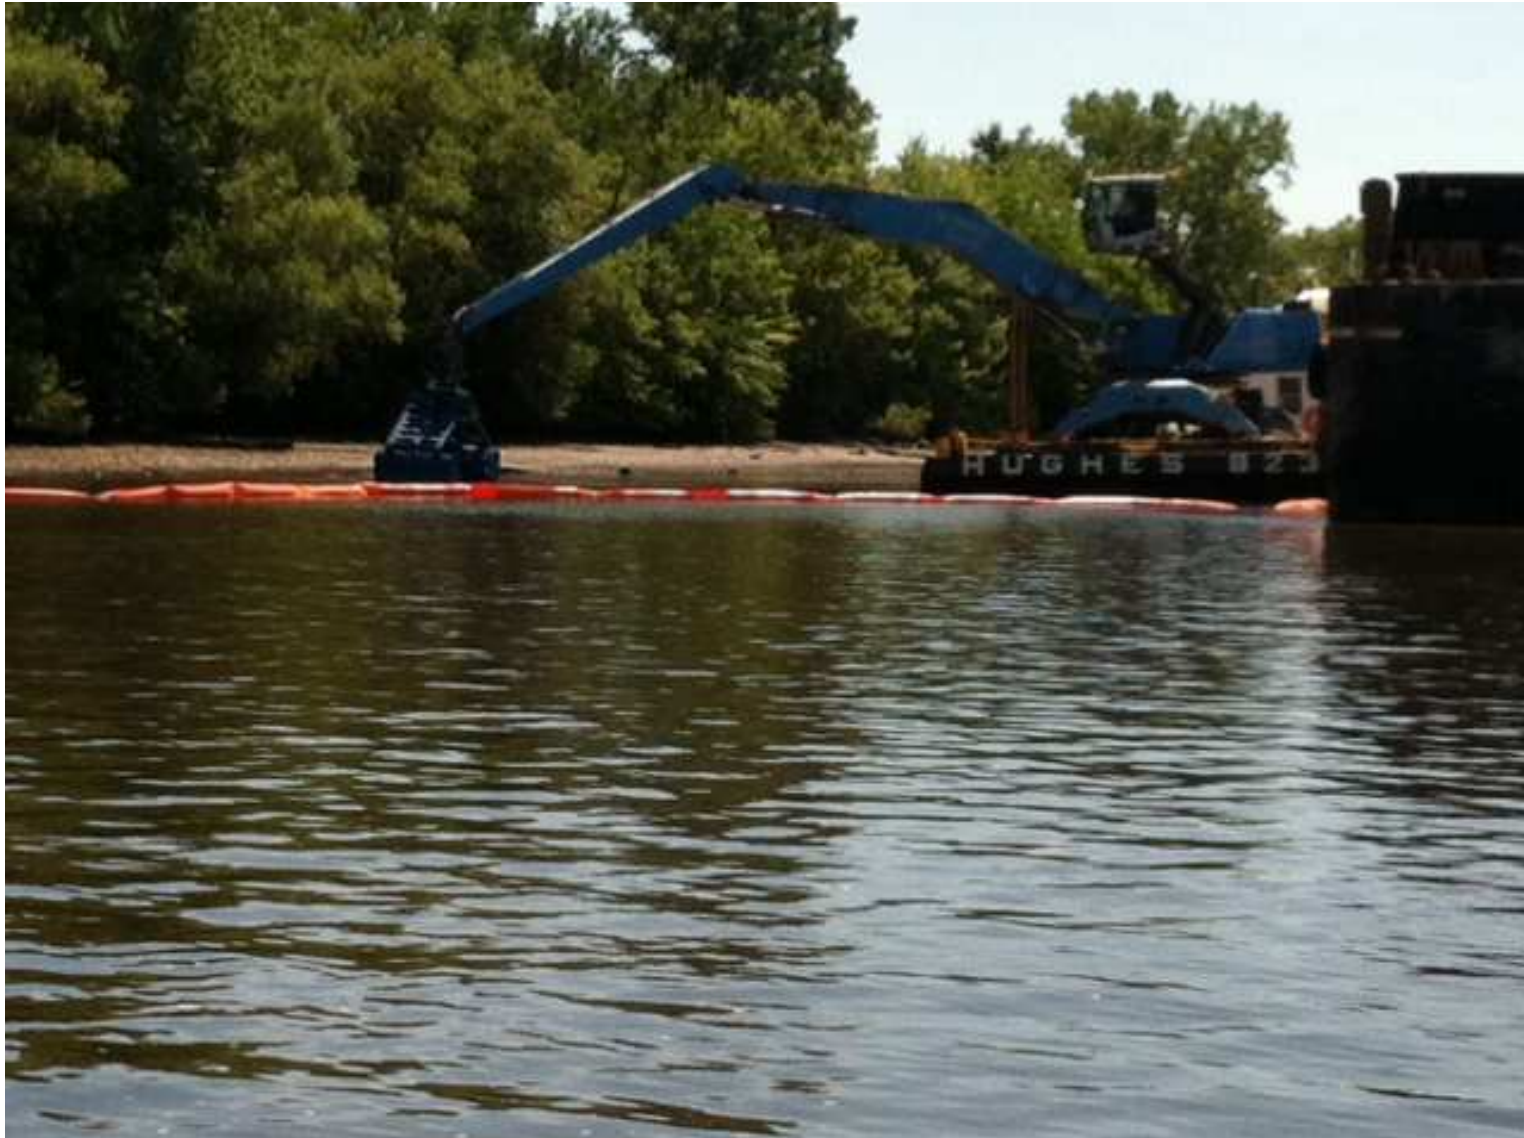
August 5 2013: Dredge cut, starting at east bank and working toward channel

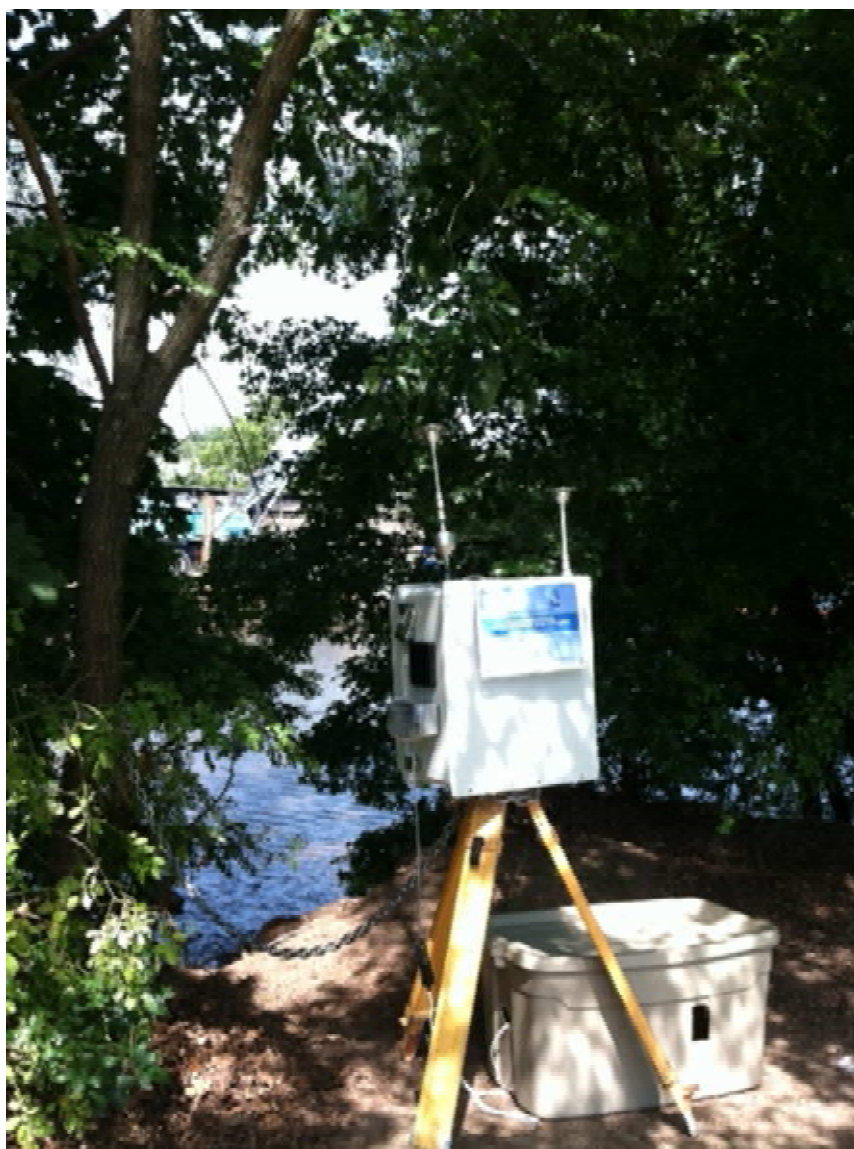
August 5 2013: Mobile in-park air monitor, positioned in close proximity to dredging operation

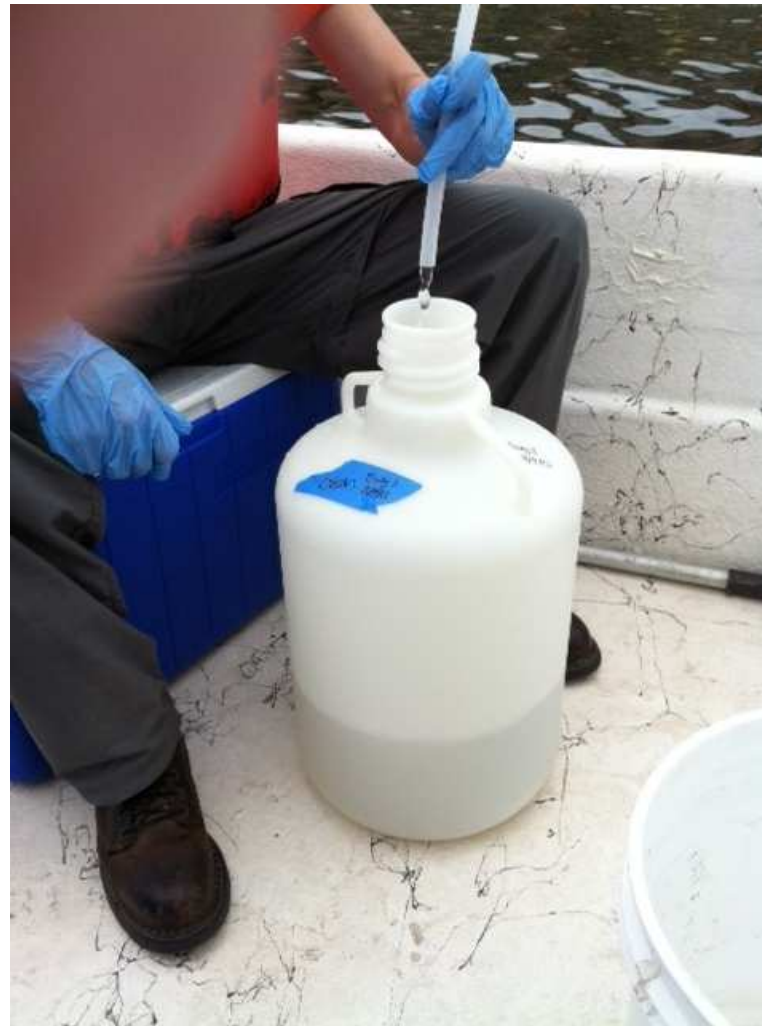
August 9, 2013 Composite surface water sampling

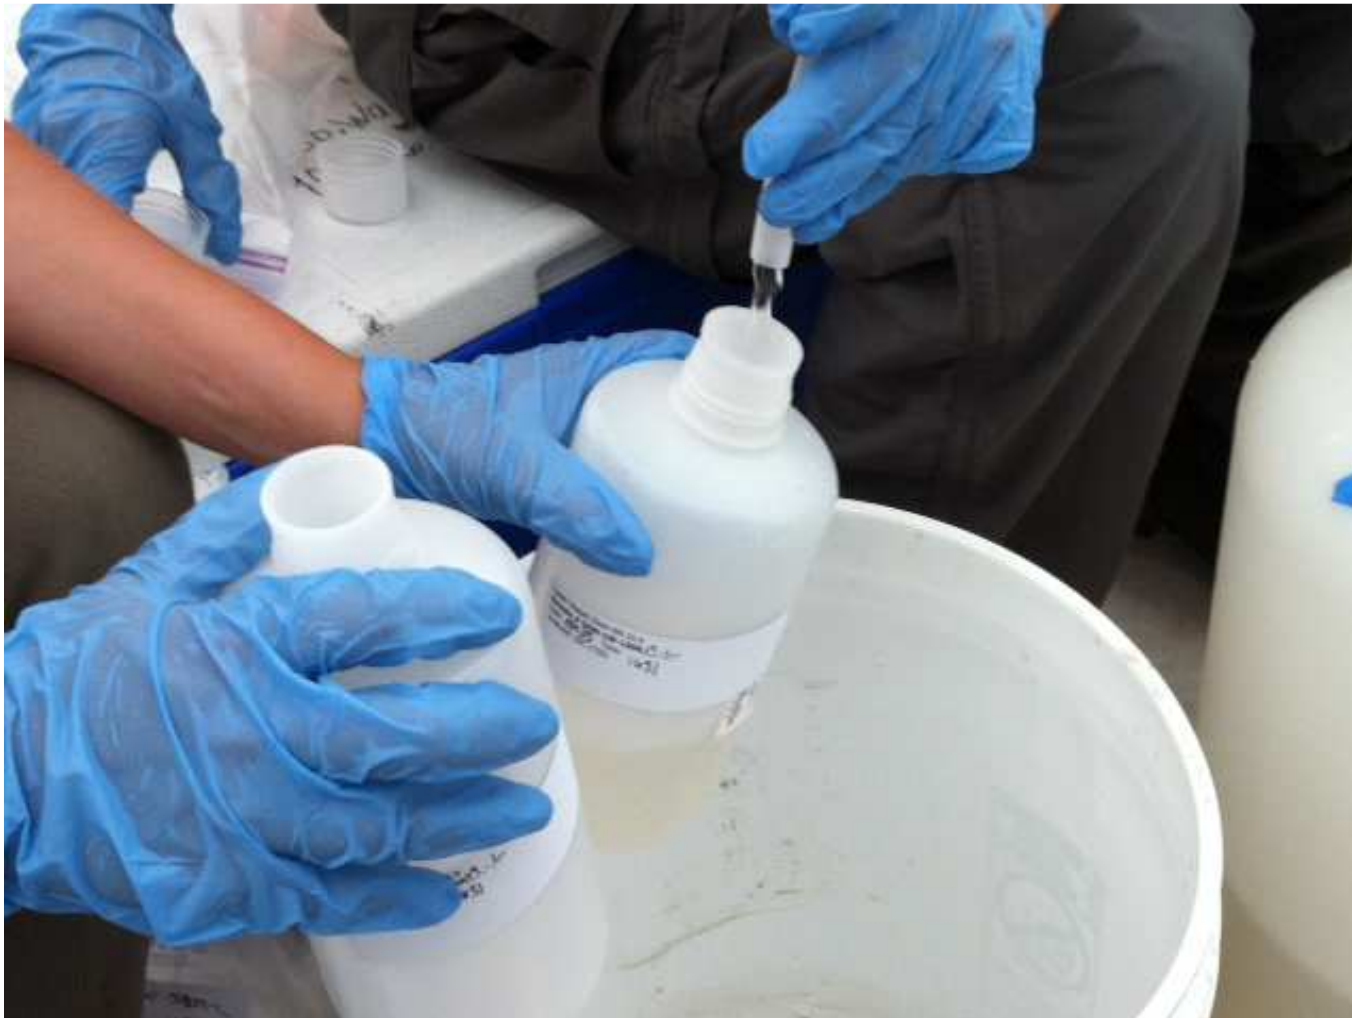
August 9, 2013: Filling TSS grab sample during transect sampling

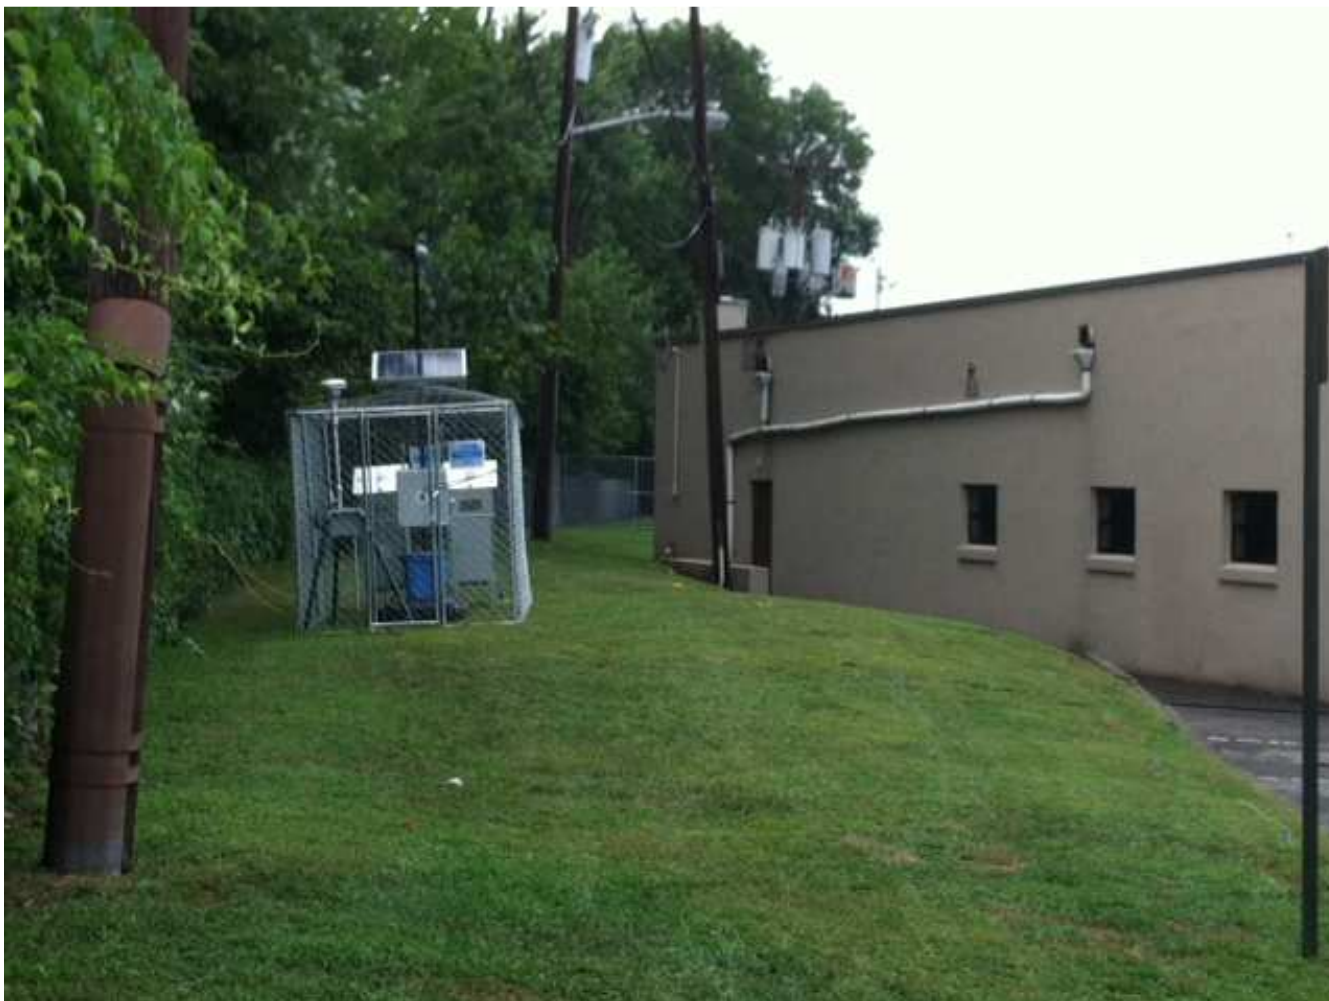
August 9, 2013: New location for northern air monitor

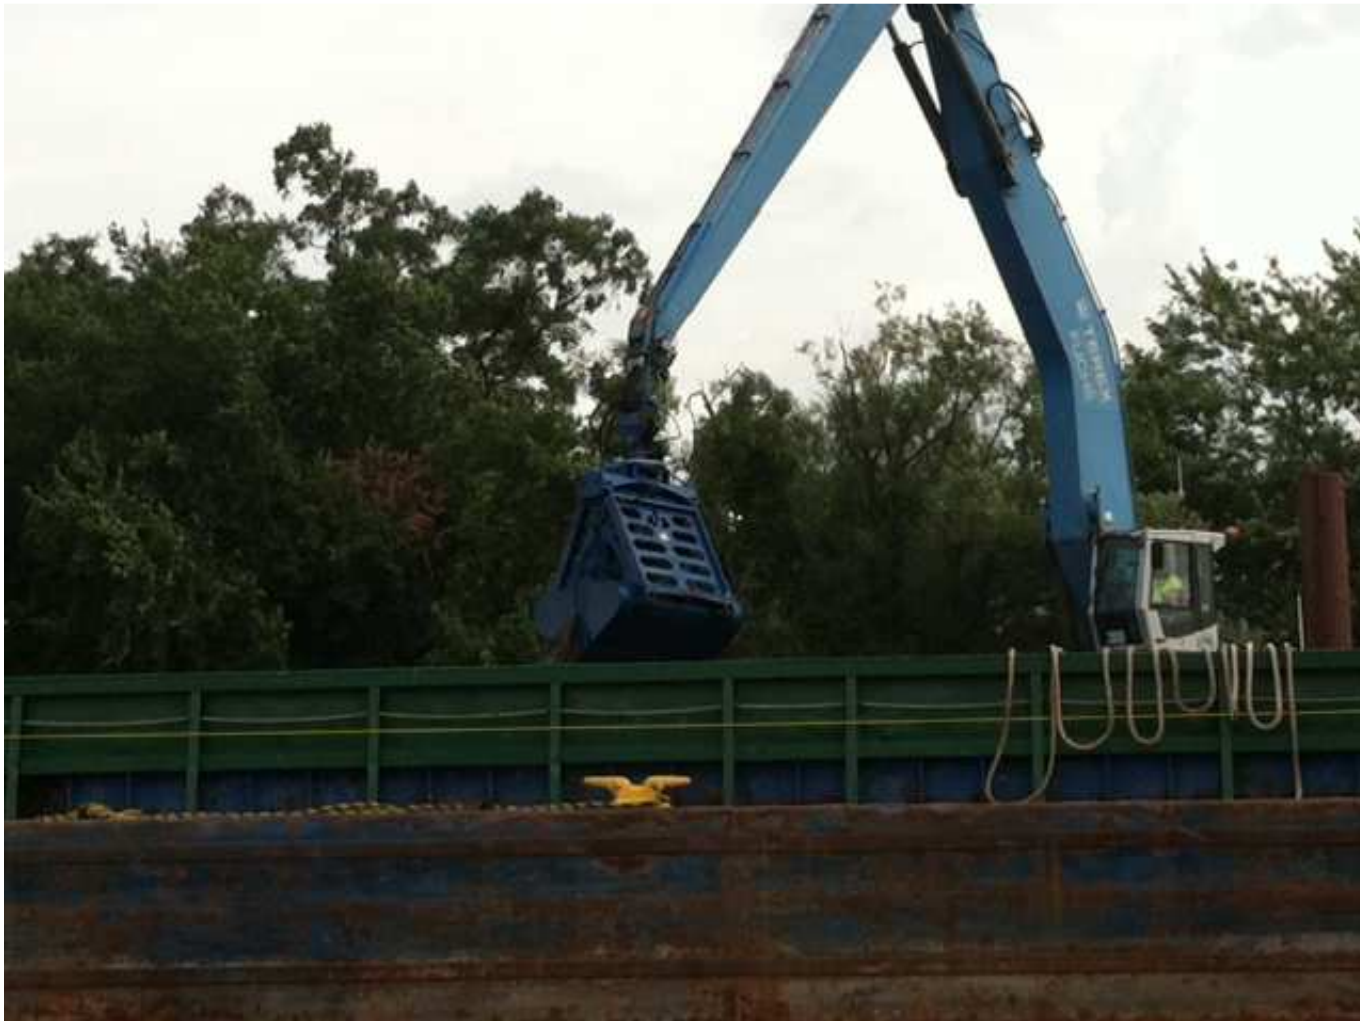
August 9, 2013: Observed sediment release from dredge bucket

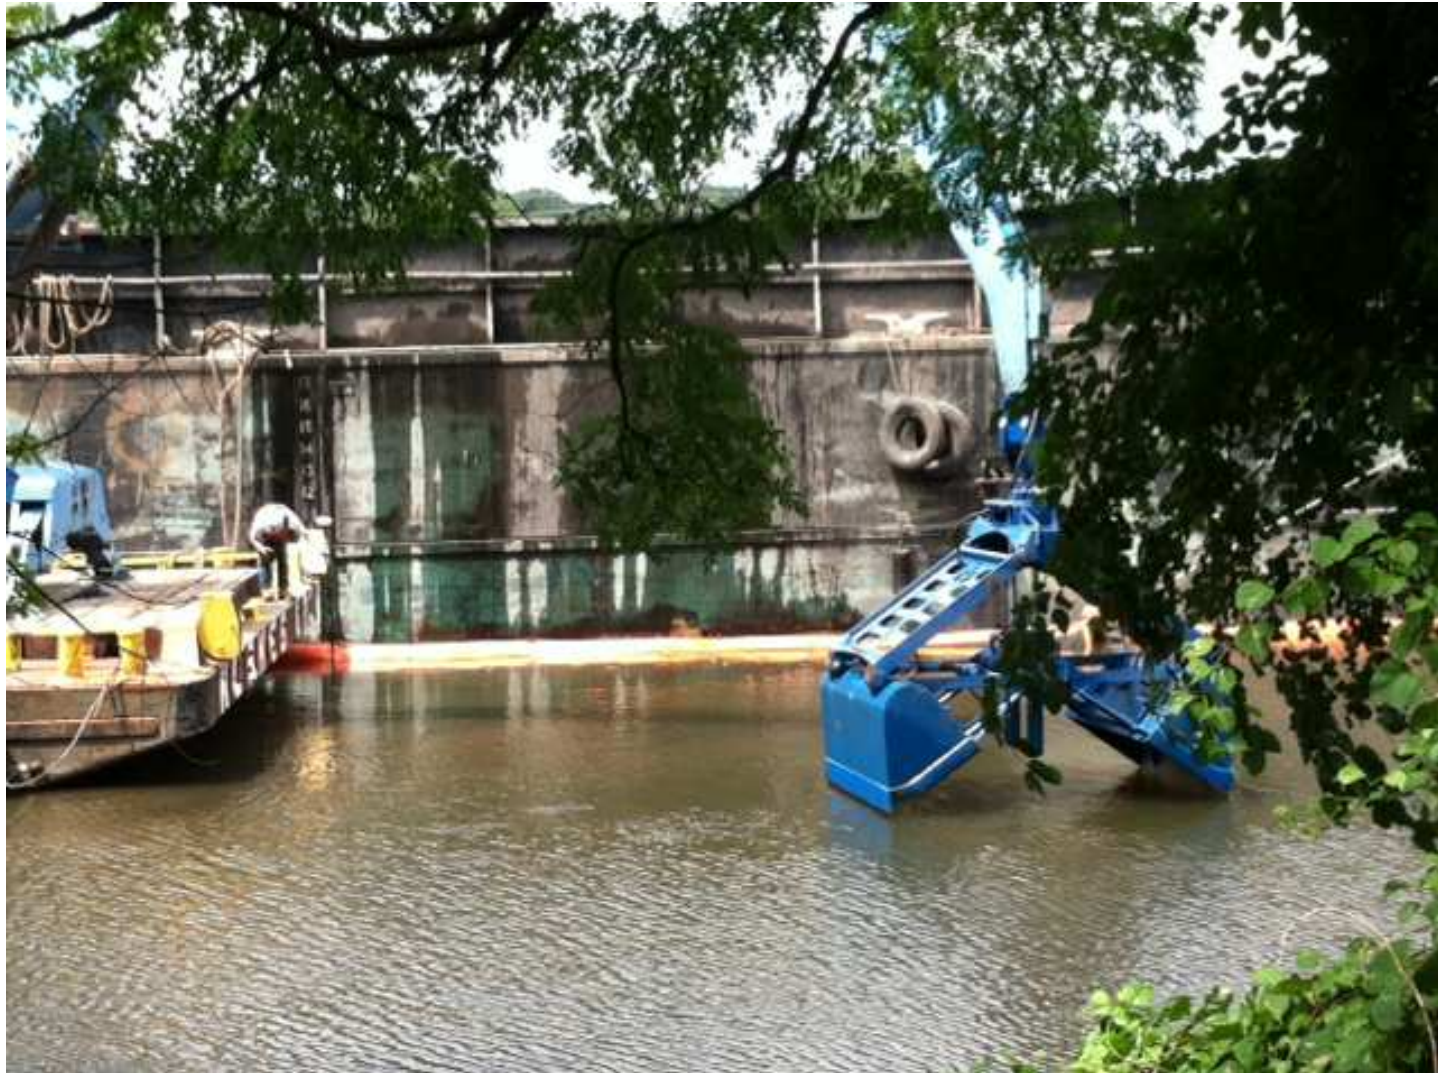
August 10, 2013 GLDD checking GPS on bucket

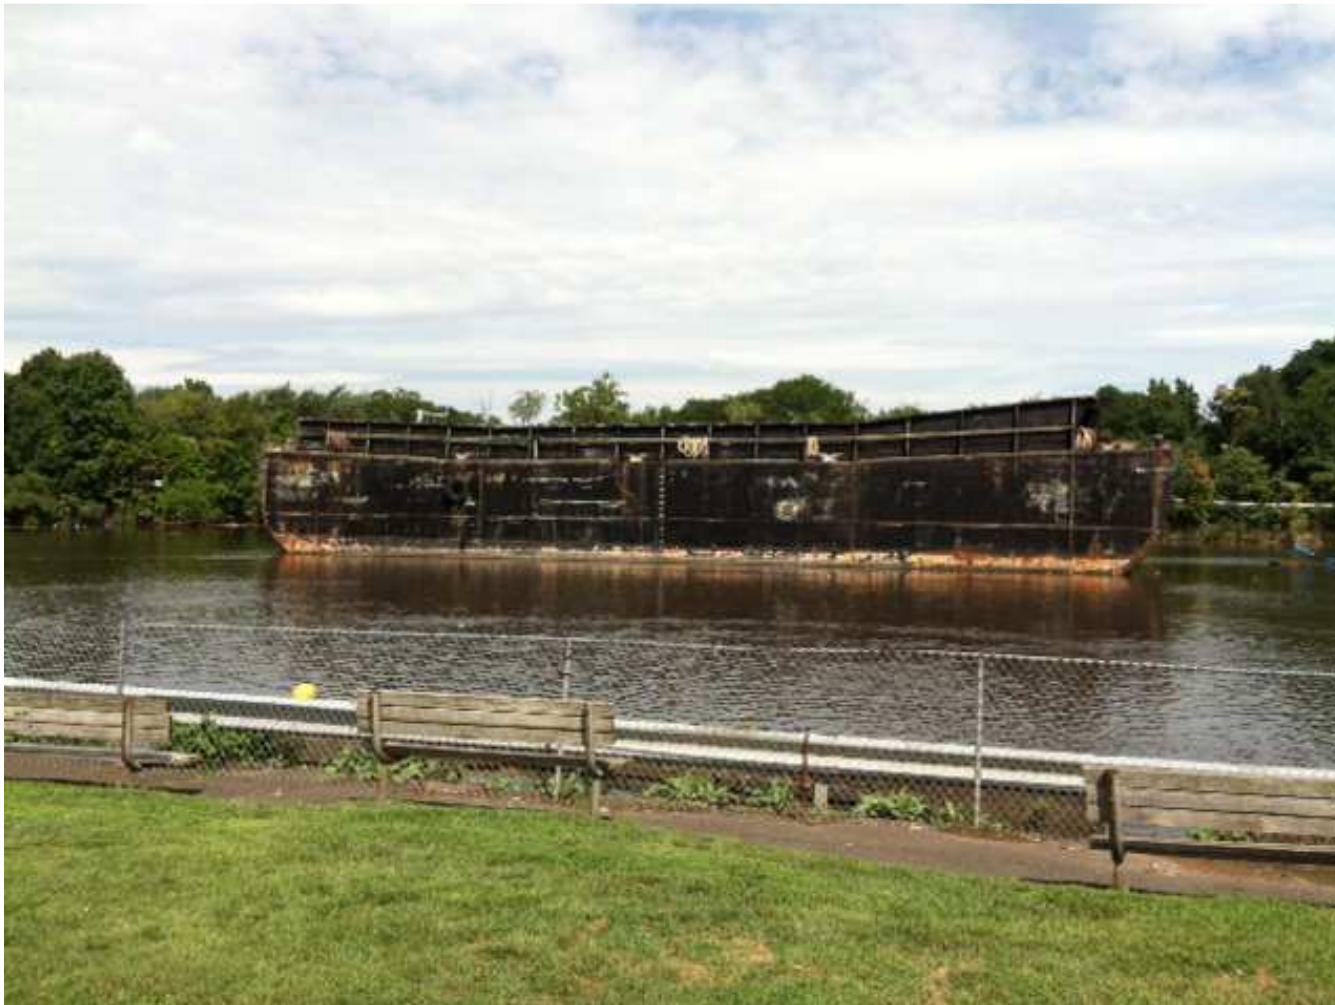
August 10, 2013: Empty scow moored across from fire department boat launch

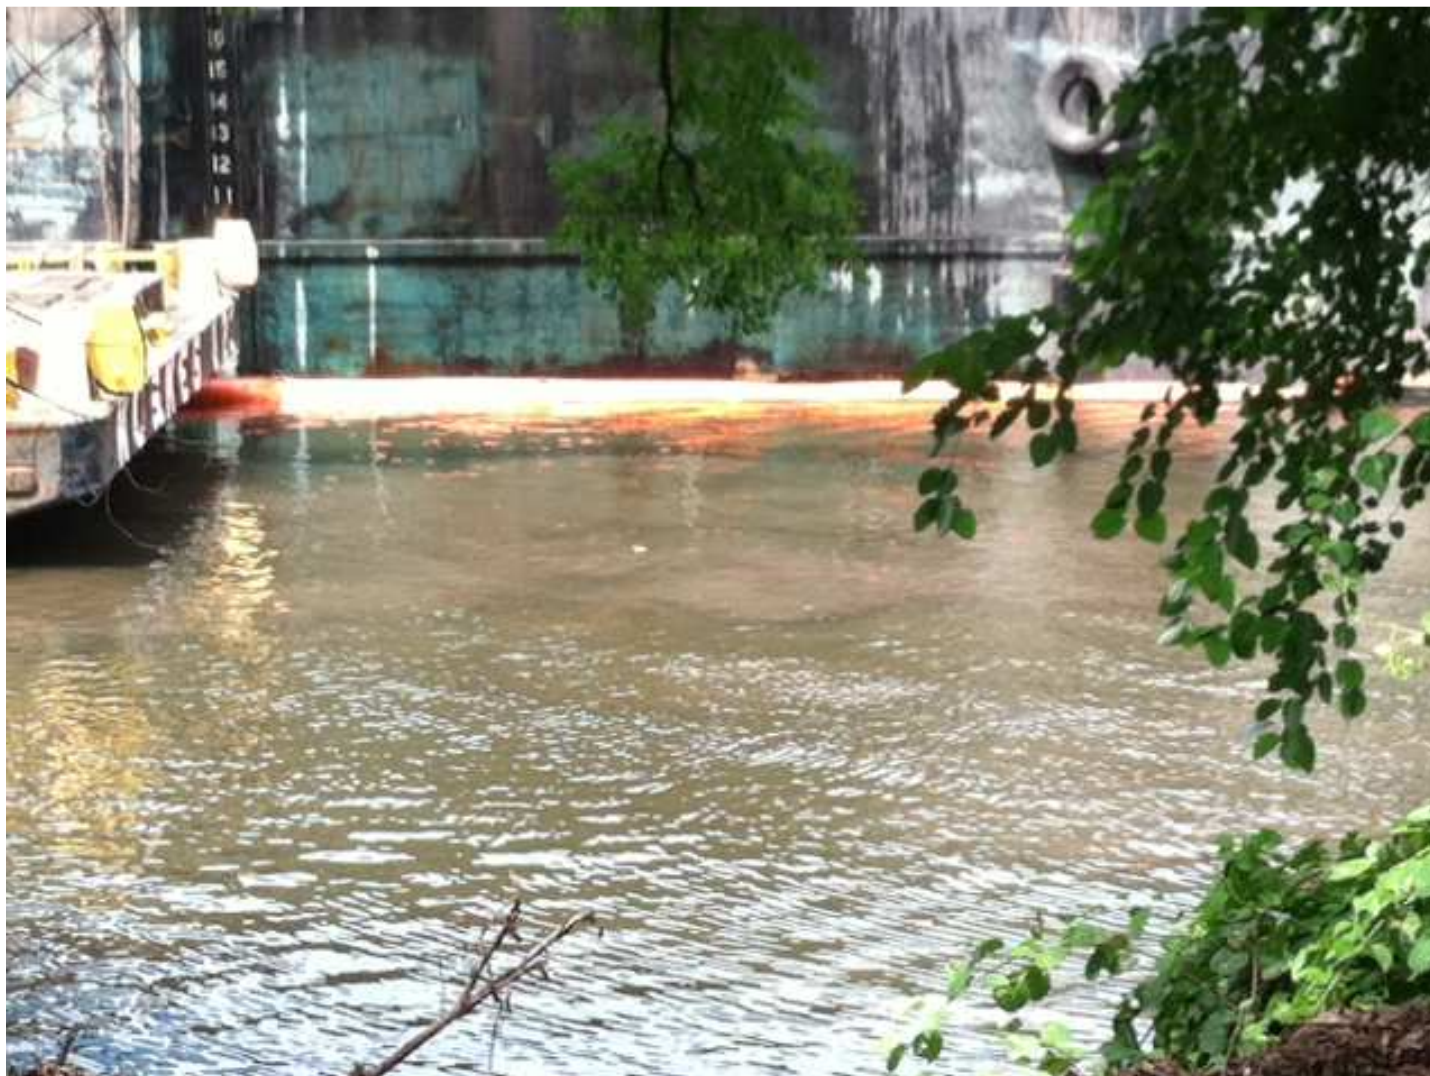
August 10, 2013: Turbidity cloud resulting from bucket cut – did not migrate

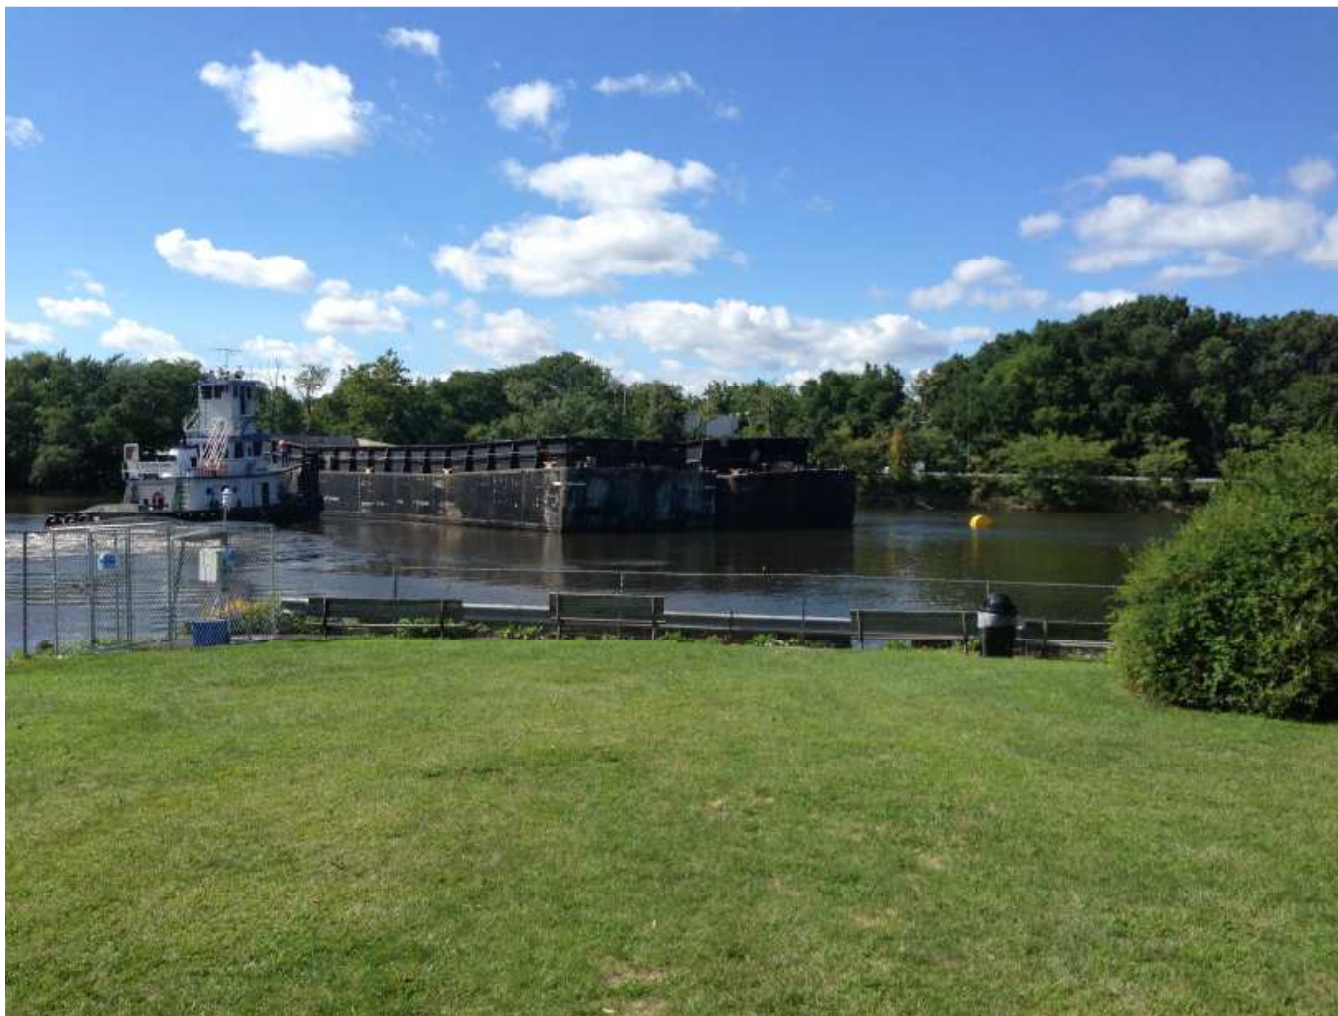
August 14, 2013: Full scows

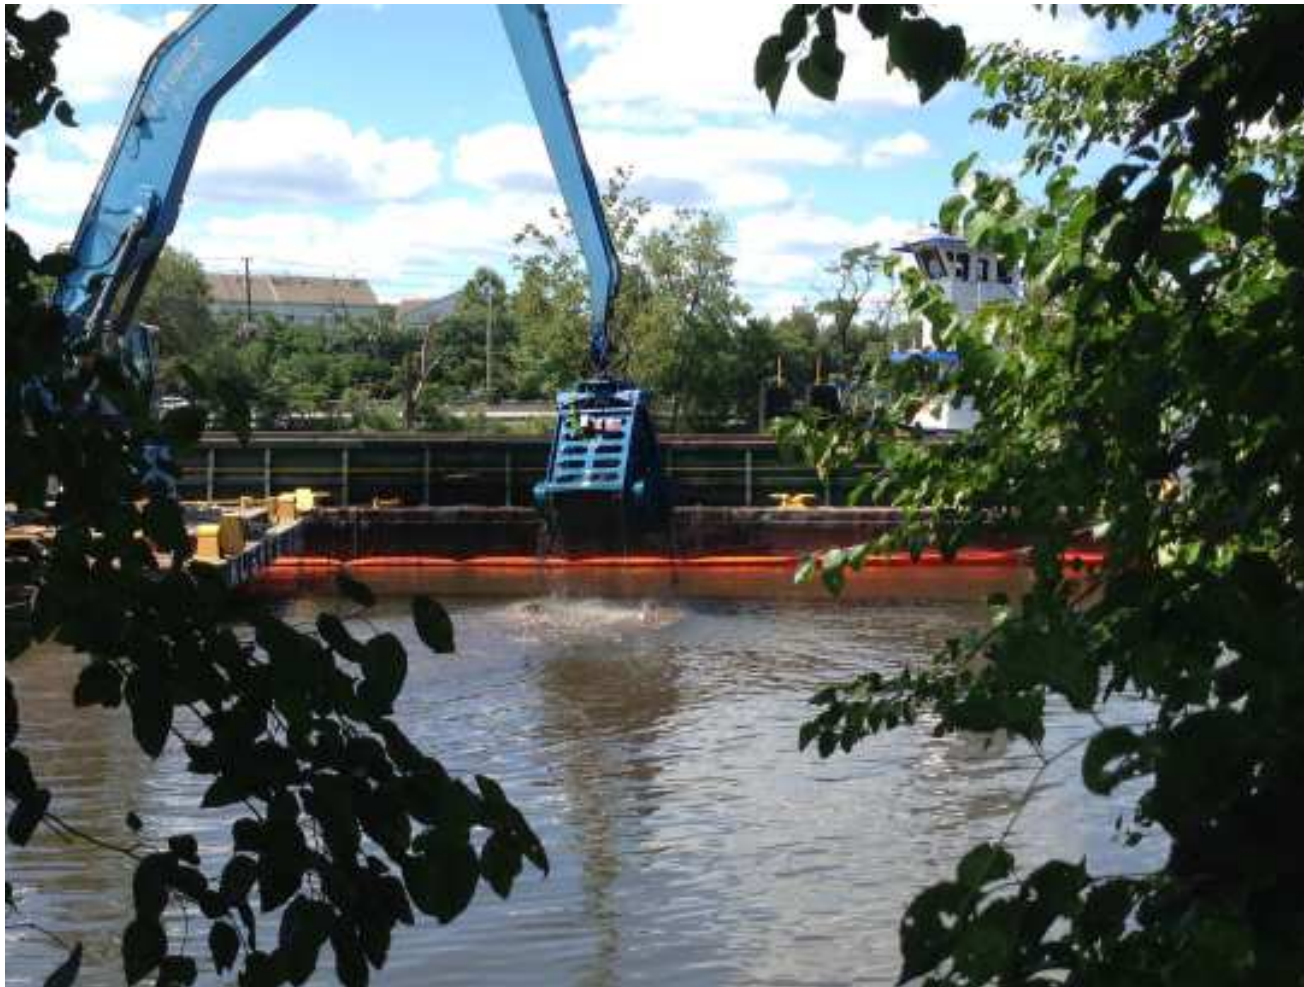
August 15, 2013: Full bucket

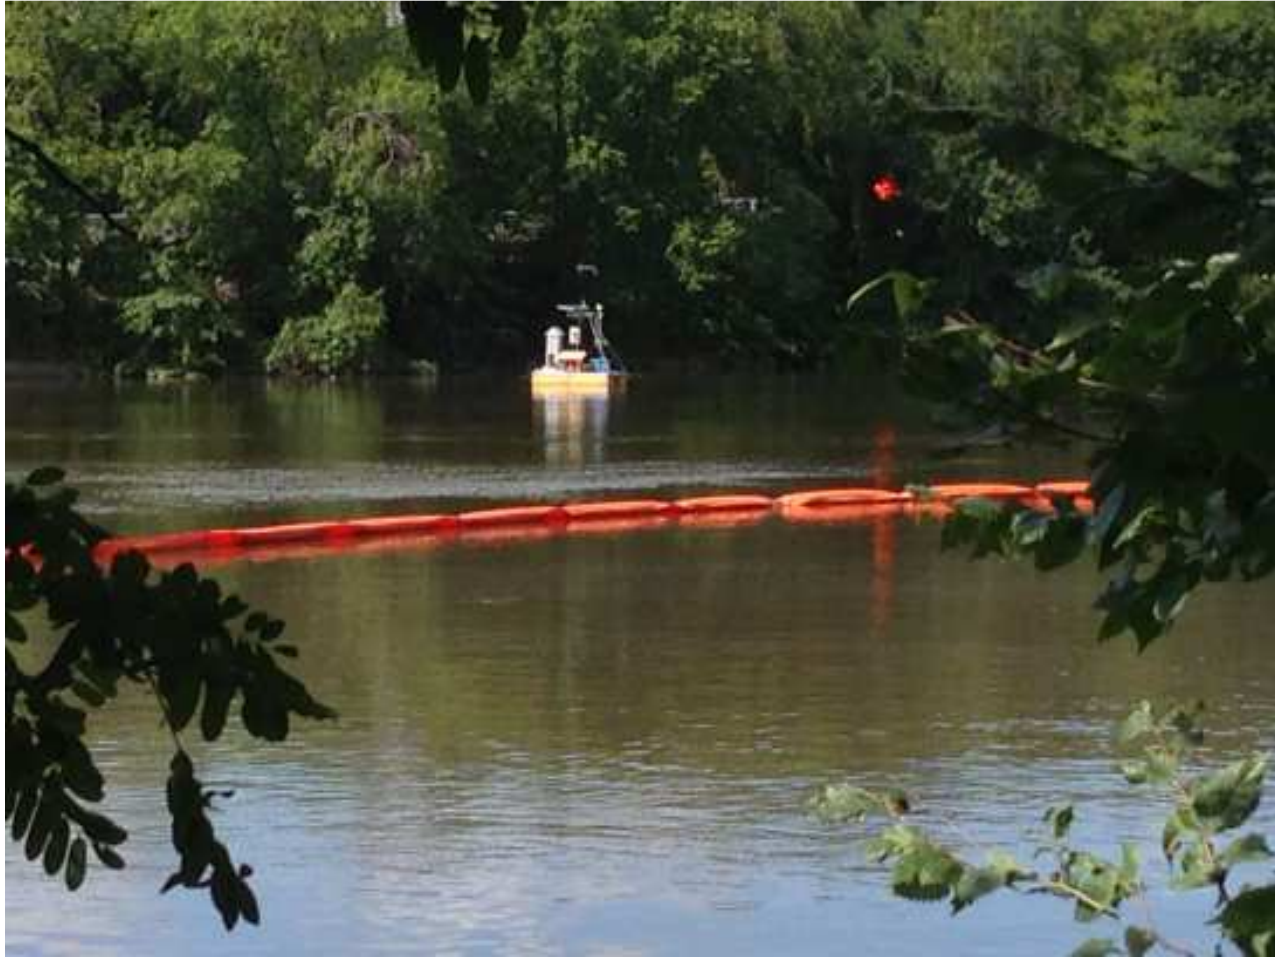
August 15, 2013: In-River Air Monitor
